12 - Electrical system

Audio system	12-1741
Preparation	12-1741
Precautions	12-1742
Structure and installation location..	12-1743
Diagnostic Information and Procedures	12-1744
Removal and installation..	12-1752

Audio system

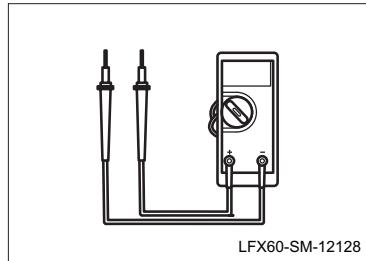
LFX60-SM-12128	-	Measure the voltage and resistance
2	Screw driver

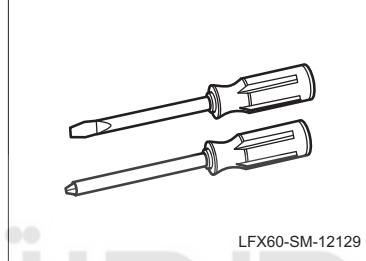
LFX60-SM-12129	-	For screw and panel removal
3	Conductor assembly

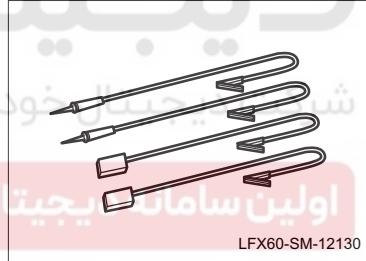
LFX60-SM-12130	-	Testing circuit

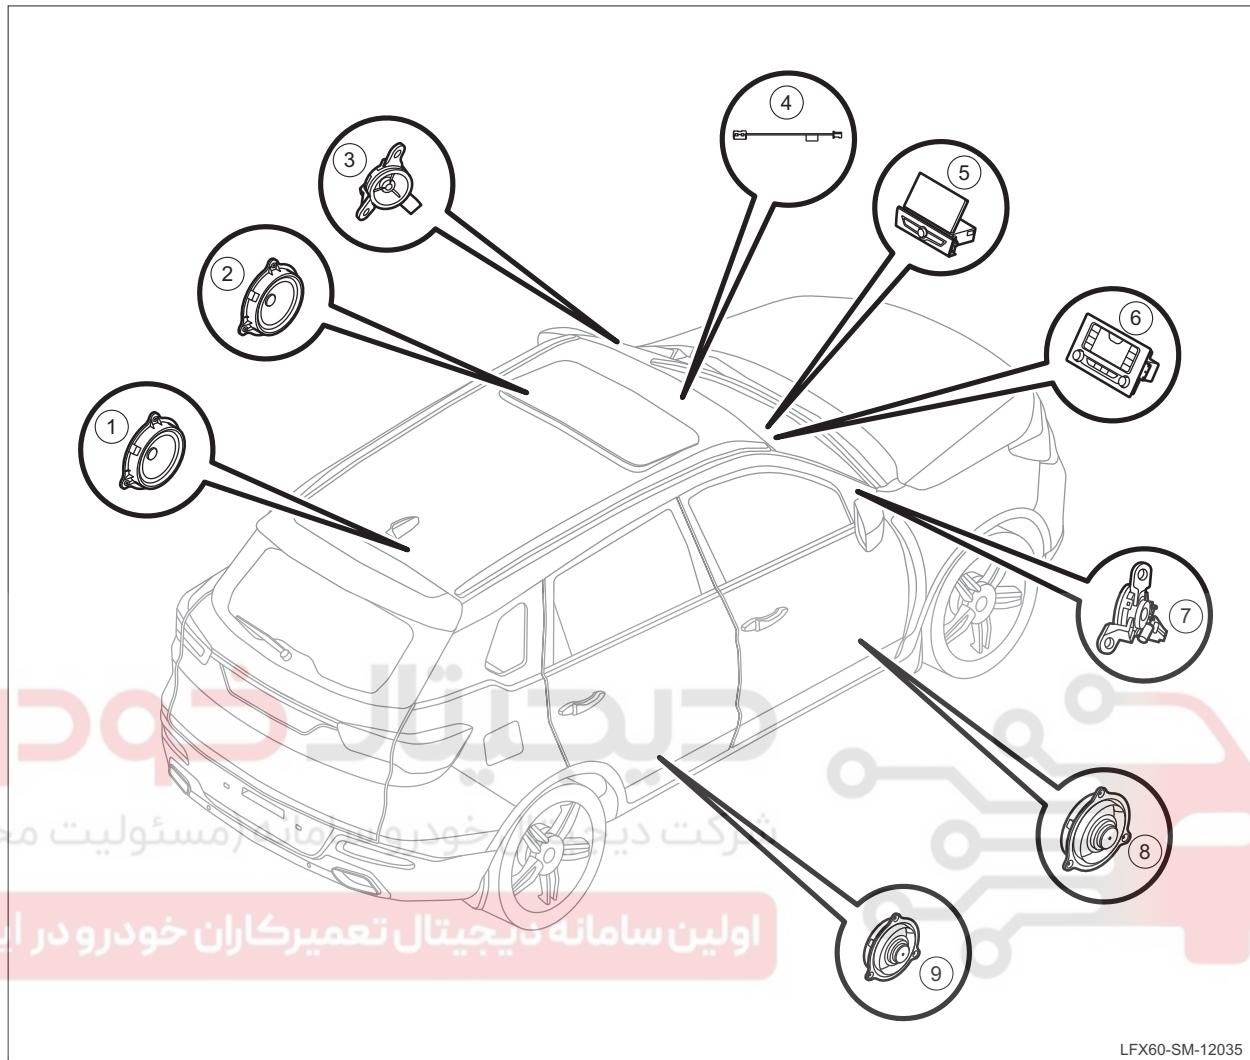
Component Location Plan

No.	Part name
1	Left rear door loadspeaker
2	Left front door loadspeaker
3	Left front high pitch horn
4	Microphone
5	Radio/MP5 player display screen

No.	Part name
6	Radio assembly
7	Right front high pitch horn
8	Right front door loadspeaker
9	Right rear door loadspeaker

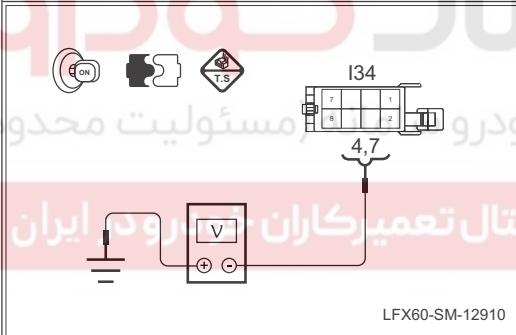
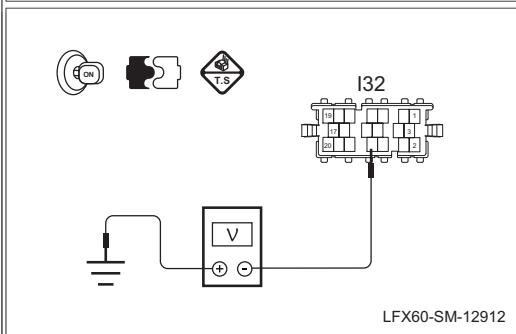
3. Check the power line of the sound system display assembly.	<p>A. Operate the ignition switch to turn the power to OFF state. B. Disconnect the battery negative connector. C. Disconnect the audio system display assembly harness plug I34. D. Disconnect the audio system display assembly harness plug I32. E. Connect the battery negative terminal. F. Operate the ignition switch to turn the power to ON state. G. Measure the voltage between the terminal 4 and 7 of the sound system display assembly harness plug I34 and reliable grounding by using a multimeter. Standard value: 11 ~ 14 V H. Measure the voltage between the terminal 11 of the sound system display assembly harness plug I32 and reliable grounding by using a multimeter. Standard value: 11 ~ 14 V Is the voltage normal? →Yes To step 4. →No Repair power line failures of the sound system display assembly. If necessary, replace the harness.</p>

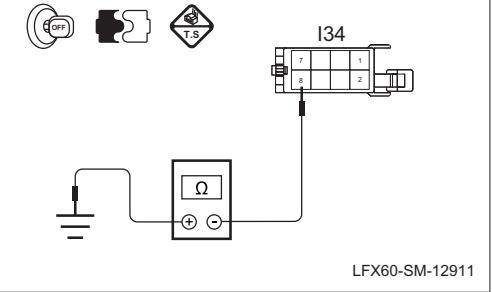
Test condition	Details/results/measures
<p>4. Check the grounding line of the sound system display assembly.</p>

<p>A. Operate the ignition switch to turn the power to OFF state. B. Disconnect the battery negative connector. C. Disconnect the audio system display assembly harness plug I34. D. Measure the resistance between the terminal 8 of the sound system display assembly harness plug I34 and reliable grounding by using a multimeter. Standard value: less than 5Ω Is the resistance normal? →Yes To step 5. →No Repair grounding line failures of the sound system display assembly. If necessary, replace the harness.</p>
<p>5. Check the audio system display assembly.</p>	<p>A. Replace the audio system display assembly. Refer to: Replacement of radio/MP5 player display Confirm that the fault has been ruled out.</p>

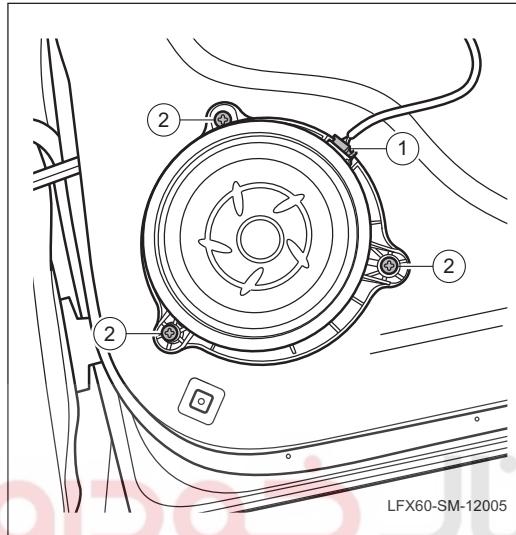
Replace the front low pitch loadspeaker

- (a). Disconnect the battery negative connector.
- (b). Remove the front door interior trim board. Refer to the replacement of front door interior trim board.

- (c). Disconnect the harness plug 1 of the front low pitch loadspeaker.
- (d). Disassemble the fixing screw 2 of the front low pitch loadspeaker.
- (e). Remove the front low pitch loadspeaker.

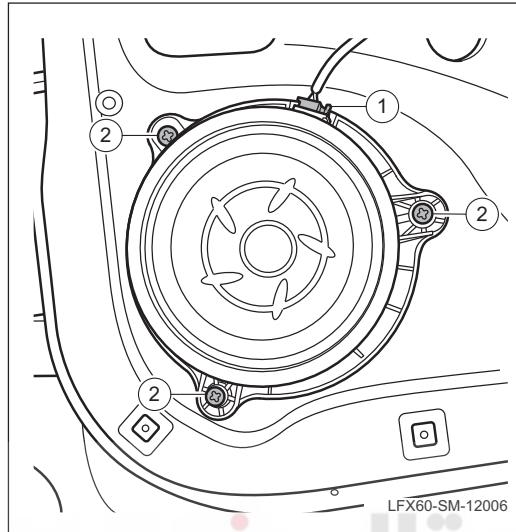
Replace the rear low pitch loadspeaker

1. Disassemble rear low pitch loadspeaker.
- (a). Disconnect the battery negative connector.
- (b). Remove the front door interior trim board. **Refer to the replacement of front door interior trim board.**

- (c). Disconnect the harness plug 1 of the rear low pitch loadspeaker.
- (d). Disassemble the fixing screw 2 of the rear low pitch loadspeaker.
- (e). Remove the rear low pitch loadspeaker.

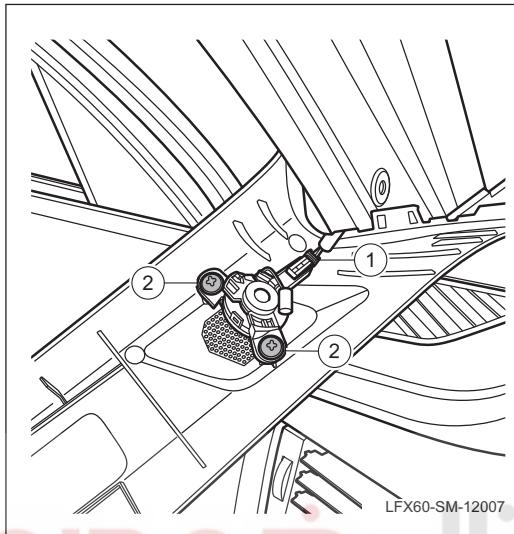
Replace the high pitch loadspeaker

1. **Disassemble the front high pitch loadspeaker.**
 - (a). Disconnect the battery negative connector.
 - (b). Remove the A pillar upper trim board. **Refer to the replacement of A pillar upper trim board.**

- (c). Disconnect the harness plug 1 of the front high pitch loadspeaker.
- (d). Disassemble fixing screw 2 of the front high pitch loadspeaker.
- (e). Remove the front high pitch loadspeaker.

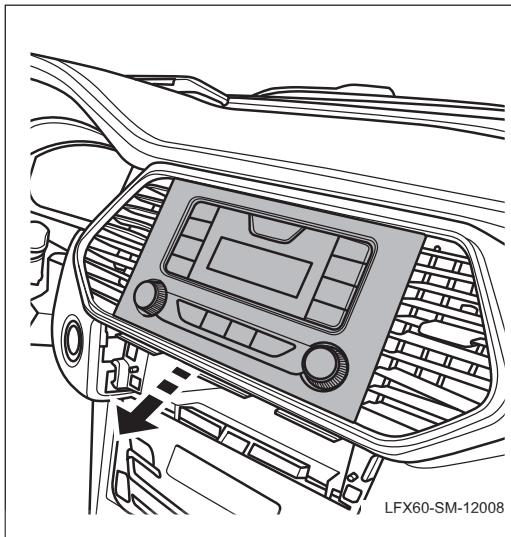
(b). Disassemble the decorative cover plate on the radio assembly.

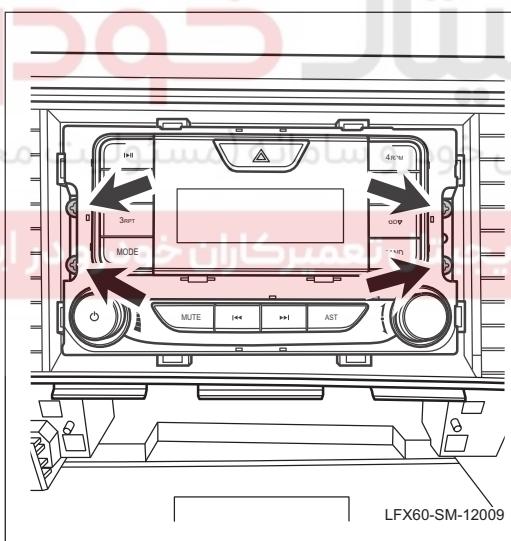
(c). Disassemble fixing screws of the radio.

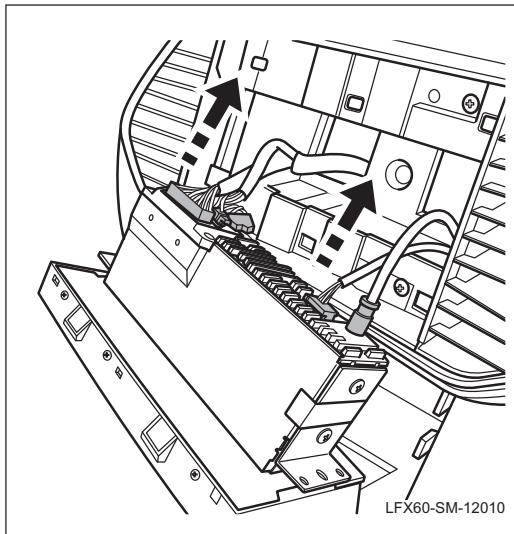
- (d). Disconnect the harness plug of the radio assembly.
- (e). Remove the radio assembly.

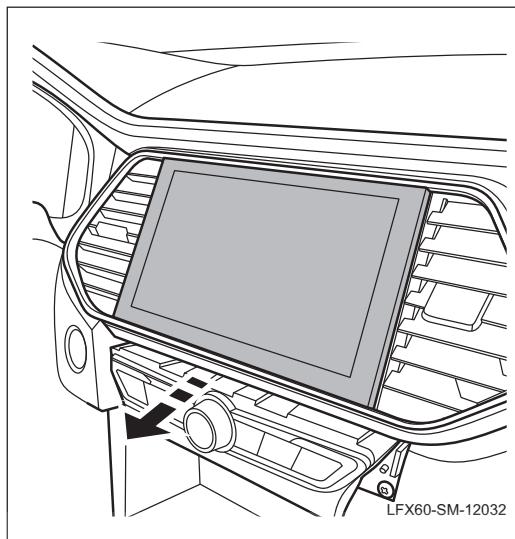
- (b). Disassemble the radio/MP5 player display screen by using a proper tool.

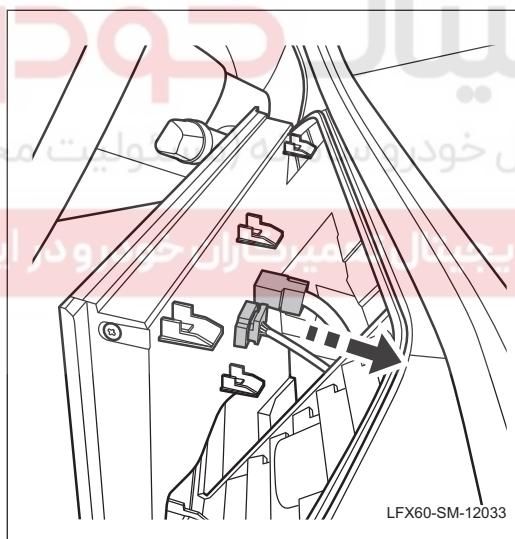
- (c). Disconnect the harness plug of the radio/MP5 player display screen.
- (d). Remove the radio/MP5 player display screen.

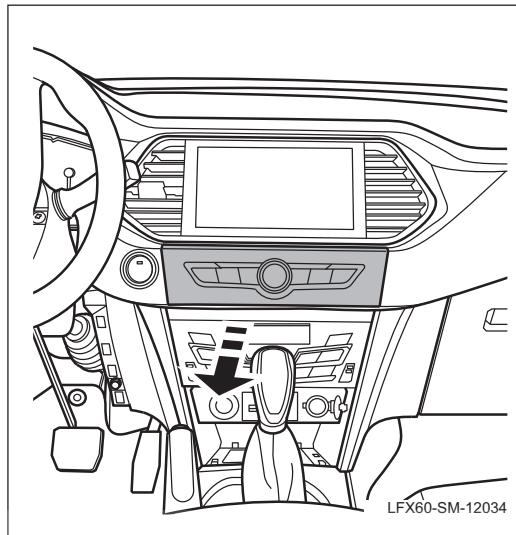
(b). Disassemble decorative cover plate of the radio/MP5 player key panel.

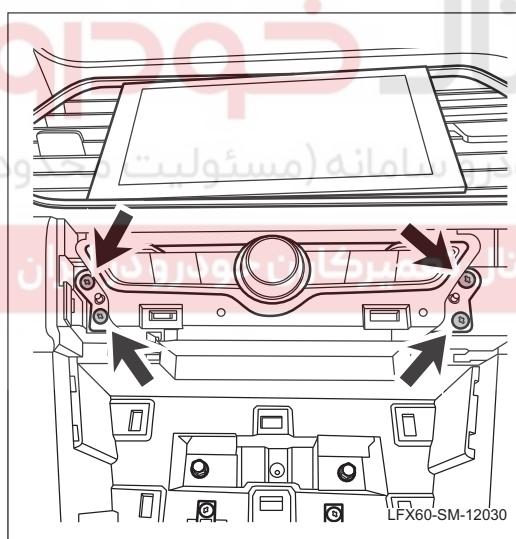
(c). Disassemble fixing screws of the radio/MP5 player key panel.

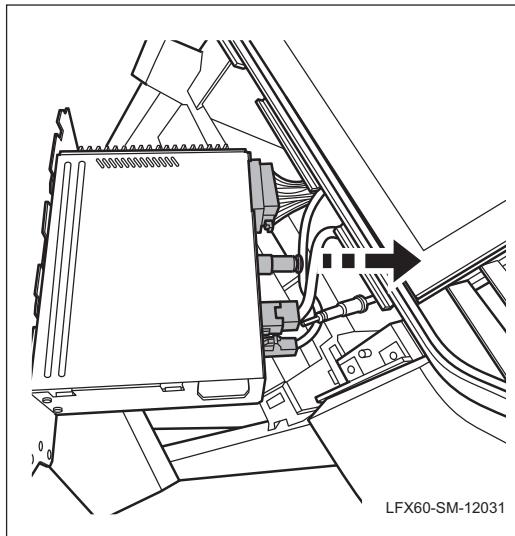
- (d). Disconnect the harness plug of the radio/MP5 player key panel.
- (e). Remove the radio/MP5 player key panel.
